Property Inspection Report

Property Address here

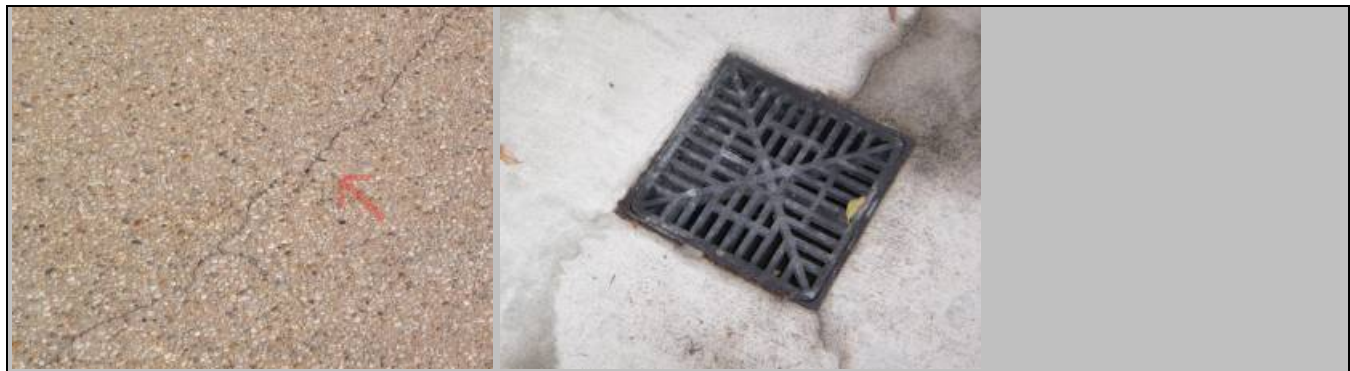
MAINTENANCE: Cracks viewed. Some cracking in paving and masonry is common. Cracks to 1/4 inch in width or displacement are within the generally acceptable range. There are many reasons for paving to crack ranging from improper mixture, thickness or curing, to movement due to settlement, unstable or expansive soil, defective drainage, tree roots, seismic activity or other reasons. Cracks can be a symptom of a present condition or the results of a past condition. We suggest repairing cracks to prevent water intrusion, which can contribute to further deterioration, and correct any drainage conditions that will allow water to accumulate near paving.

DEFERRED: To determine the cause of cracks viewed we recommend further evaluation by a qualified geotechnical engineer and a qualified arborist if trees are present.

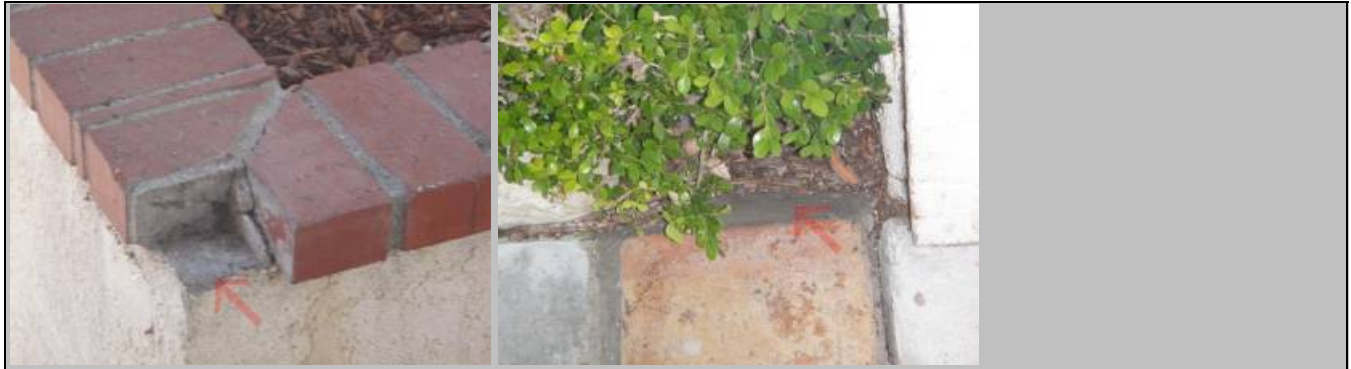
2.3 Planters

MAINTENANCE: Some loose/broken/missing blocks or caps.

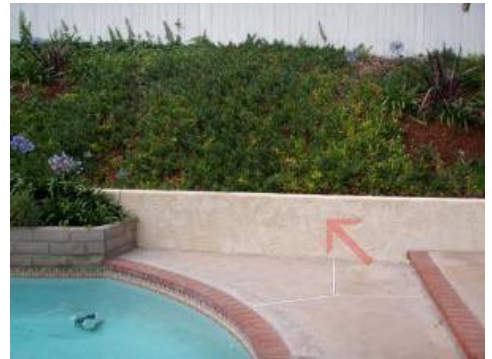
2.4 Retaining walls

DEFERRED: Retaining walls are beyond the scope of a professional home inspection and are not fully evaluated. The primary purpose of retaining walls is to provide lateral support for soil and rock. We are not qualified to evaluate or comment on the structural soundness, or on the presence, absence of, or effectiveness of drainage or damp-proofing of these walls. Any concerns about retaining walls should be addressed to a geotechnical engineer.

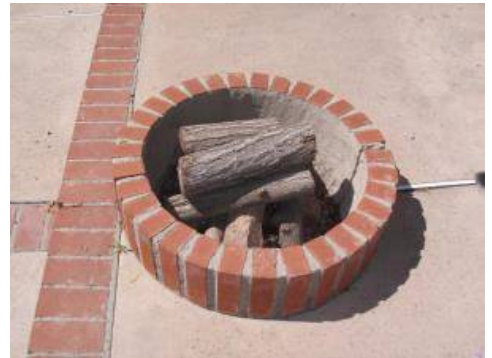
2.5 Inspector's comments

DEFERRED: Fire pits are beyond the scope of a professional home inspection and are not inspected.

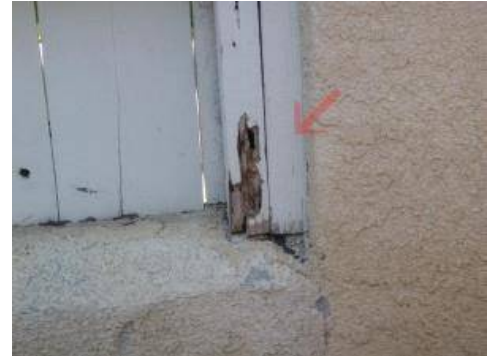
MAINTENANCE: Damage to wood fence on east side of house.

DEFERRED: Insect damage viewed.

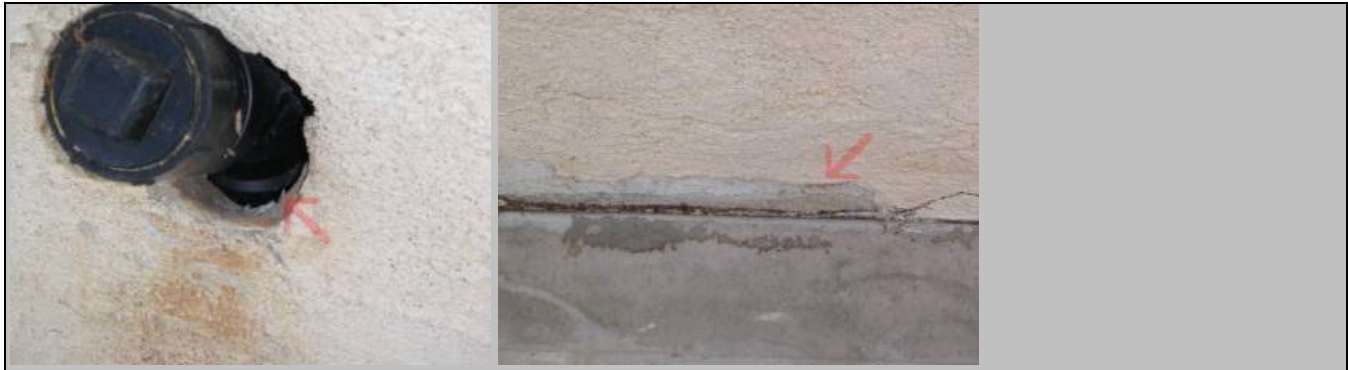
DEFECTIVE: Unsealed penetration(s) viewed. Plumbing, electrical and other penetrations through the stucco should be properly flashed and sealed to prevent moisture intrusion.

MAINTENANCE: Deterioration noted to the stucco at grade; no stucco weep screed installed. In older homes the stucco was continued to or below the finish grade level. This condition can allow moisture and corrosive minerals to be "wicked-up" by the stucco, which can cause deterioration of the stucco near the ground.

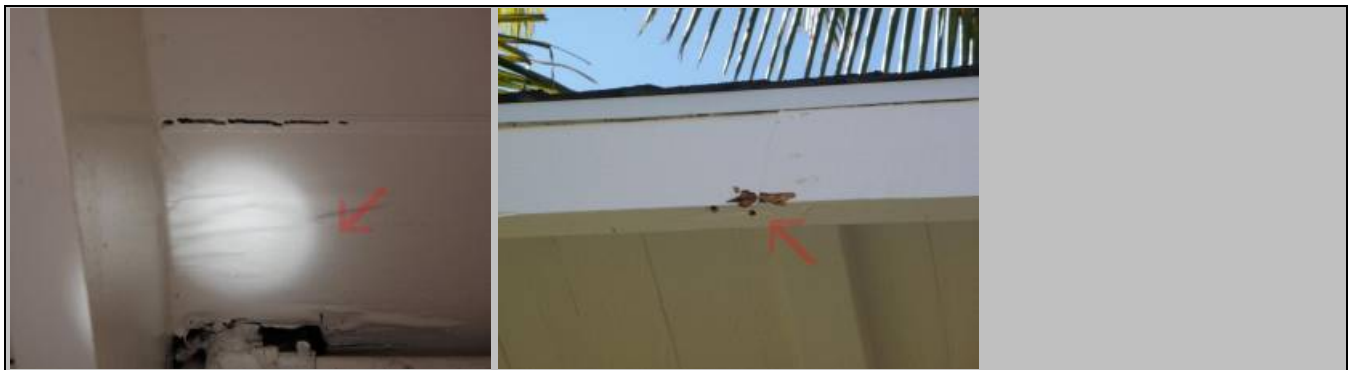
3.2 Eaves and trim

DEFERRED: Wood rot viewed, at the eaves indicates a history of roof leakage.

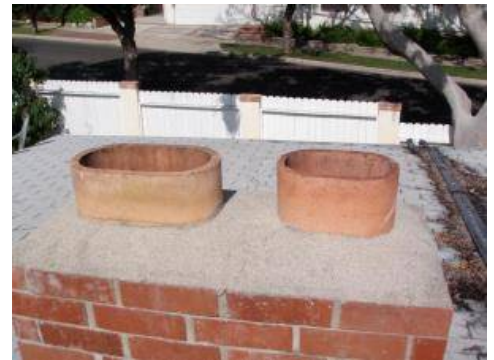
SAFETY: No spark arrester or improper spark arrester. Solid fuel burning fireplaces are generally required to have an approved spark arrester installed with a net free area at least four times the area of the chimney outlet to contain burning embers.

MAINTENANCE: No rain cap. Rain caps are not required on masonry chimneys; however, they protect the chimney and firebox from deterioration and we recommend installing them on all chimneys.

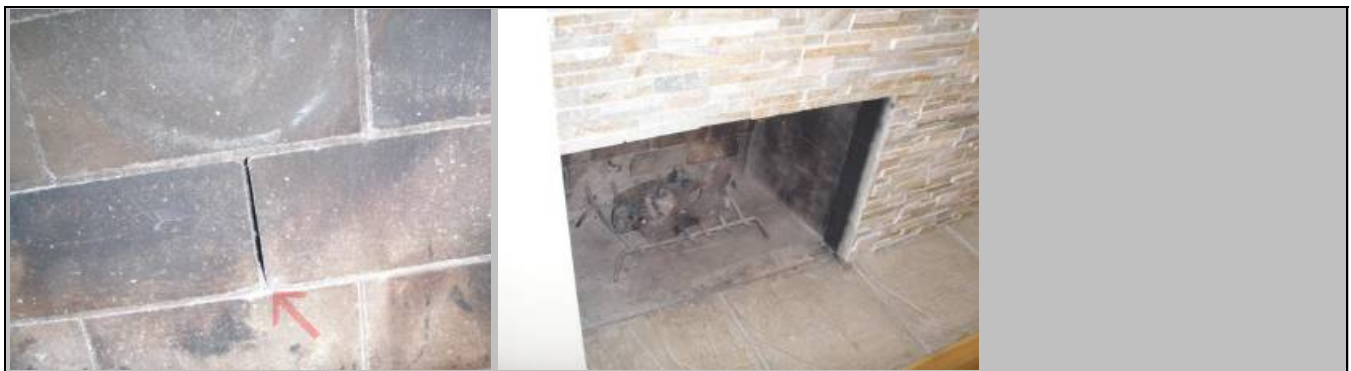
DEFECTIVE: No fire screen. We recommend installing a fire screen or approved doors on the fireplace to contain hot embers and prevent items from coming into contact with the fire.

MAINTENANCE: Damper is frozen or otherwise inoperable. We recommend repairing or replacing the damper or installing glass doors to reduce loss of conditioned air through the chimney.

DEFECTIVE: Cracks or gaps viewed in the firebox. Breaches in the firebox can allow heated gases to escape into the wall cavity and is a potential fire hazard.

DEFERRED: Two flues going out only one firebox.

We recommend further evaluation by a qualified fireplace contractor and correction as needed.

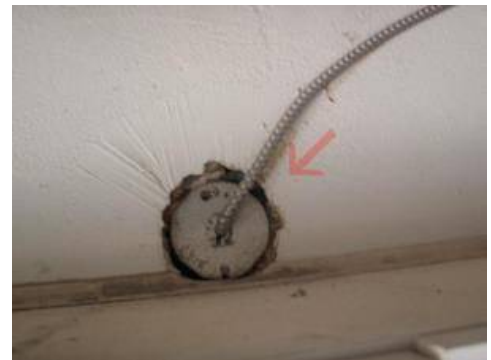
5.6 Fire separation

DEFECTIVE: Excessive annular space around pipe at one or more penetrations. Space around firewall penetrations should be tight to prevent the spread of fire.

DEFECTIVE: Improper or no fire door provided to the attic. Fire separation is designed to slow the spread of fire originating in the garage. We recommend a self closing, self latching fire door be installed as per current standards at the attic access opening.

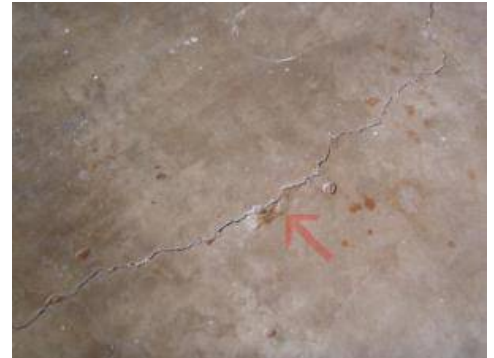
5.8 Floor

MAINTENANCE: Cracks viewed in the paving to approximately 1/2 inch indicating settlement or lifting at a number of locations. We suggest repairing cracks to prevent water intrusion which can contribute to further deterioration and correct any drainage conditions that will allow water to accumulate near paving. We recommend further evaluation by a licensed concrete contractor and correction as needed.

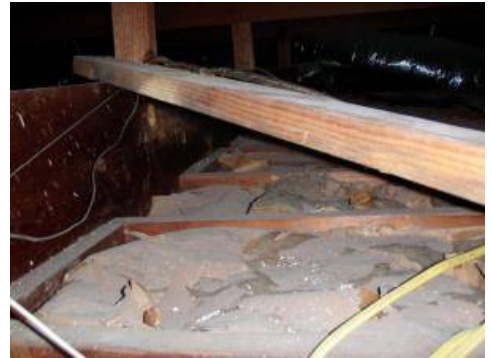
Minimal insulation. We recommend installing additional insulation for improved energy efficiency.

DEFECTIVE: Insulation is installed with the moisture barrier facing the wrong direction. Insulation should be installed with the moisture barrier facing the heated side (interior) to prevent condensation moisture from becoming trapped. We recommend further evaluation and correction as needed at this time by a licensed insulation contractor and pest control operator as trapped moisture can create an ideal environment for wood destroying insects and harmful microorganisms.

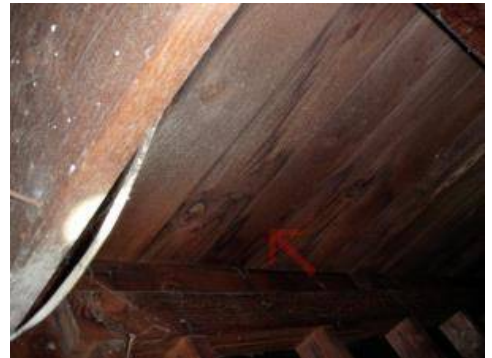
DEFERRED: Water stains viewed. We can't tell the age of stains from appearance; however, we suspect possible current leakage. Also see roof covering notes below for additional information.

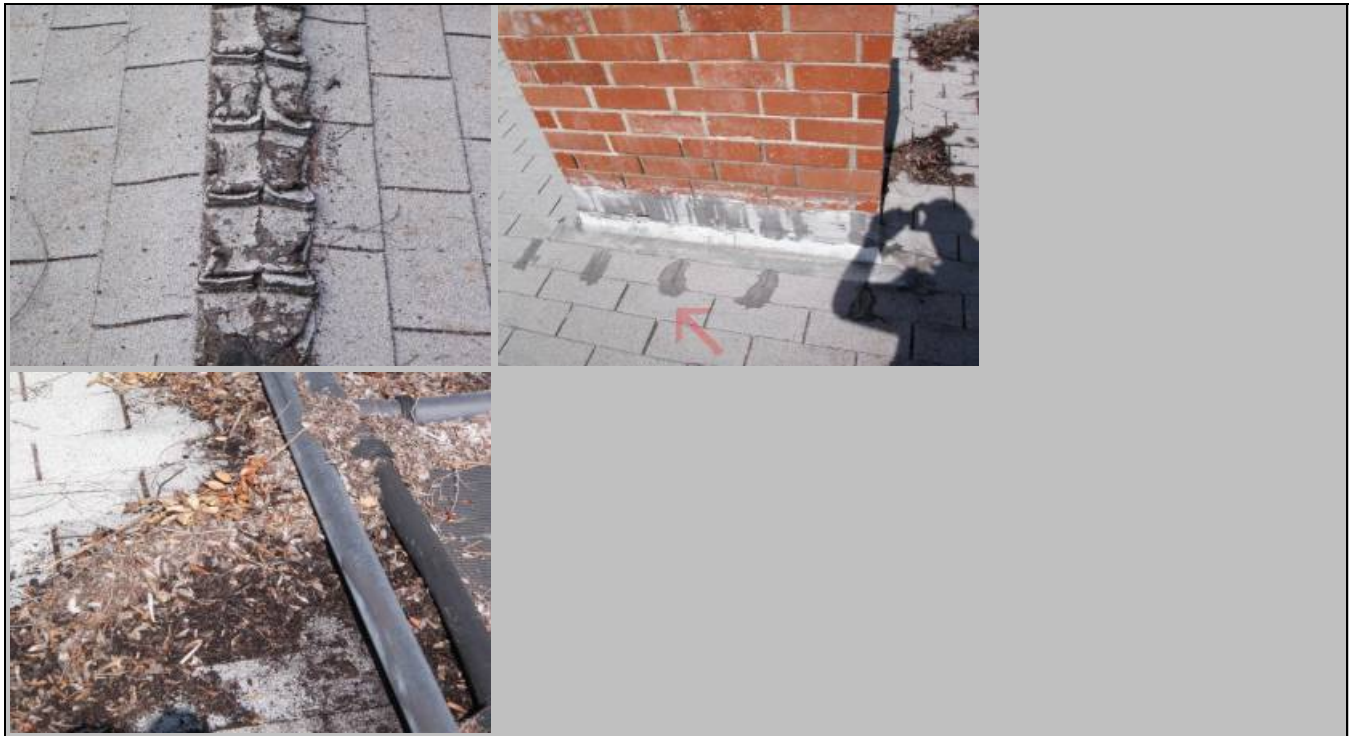
DEFERRED: Aging/weathering/deterioration viewed at the ridge shingles. We recommend correction as needed at this time to prevent leakage.

DEFERRED: Repairs/patching observed may indicate a history of leakage. We suggest asking the current owner to disclose any repairs or leaks, past or present.

MAINTENANCE: Vegetation near or touching the roof surface. We recommend maintaining vegetation growth near the roof as needed to prevent damage to the roofing materials.

DEFERRED: Vegetation or other debris on roof. We could not view the roof covering in this area and recommend removing debris and further evaluation by a licensed roofing contractor prior to the close of this transaction.

DEFECTIVE: Post supporting weather head is not sealed properly at roof.

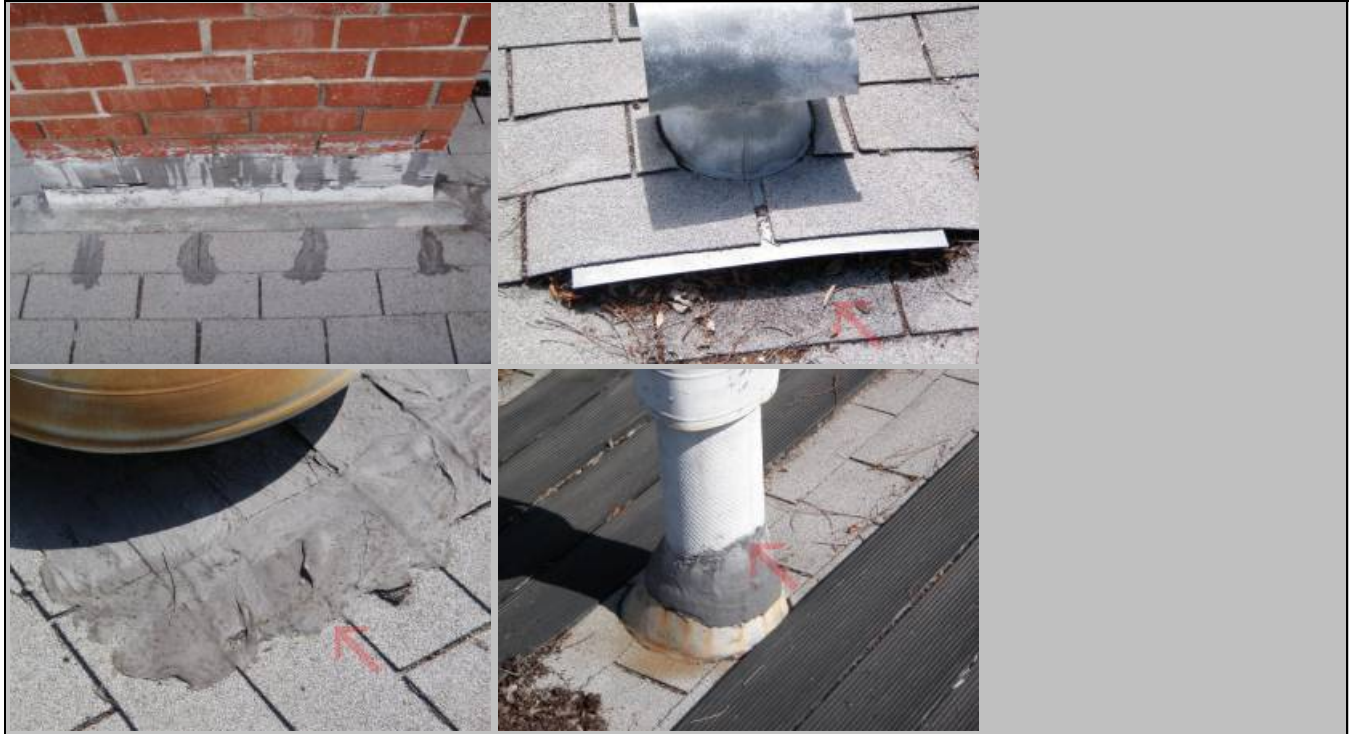
6.8 Exposed flashings

MAINTENANCE: Mastic is cracked/deteriorated at the pipe penetrations. We recommend corrections as needed at this time to prevent leakage.

DEFECTIVE: Storm collar is missing. Gas flues should have a storm collar in lieu of roofers' mastic to guard against water intrusion.

DEFECTIVE: Pipe penetration flashings were not replaced/reset when the roof was re-roofed. This type of installation is prone to leaking and should be corrected or at least monitored for application of mastic as needed to maintain a weather-tight seal. The recommended installation method is to reset/replace the flashings with the upper portion of the flashing beneath the shingles and the lower portion on top of the shingles.

DEFECTIVE: Flashings at the chimney are improperly installed, missing or not visible. These connections are prone to leakage if not properly flashed.

DEFECTIVE: Cricket flashing is not installed at the chimney. A "cricket" flashing should be installed at

chimneys over 30" wide to promote positive runoff. These connections are prone to leakage if not properly flashed.

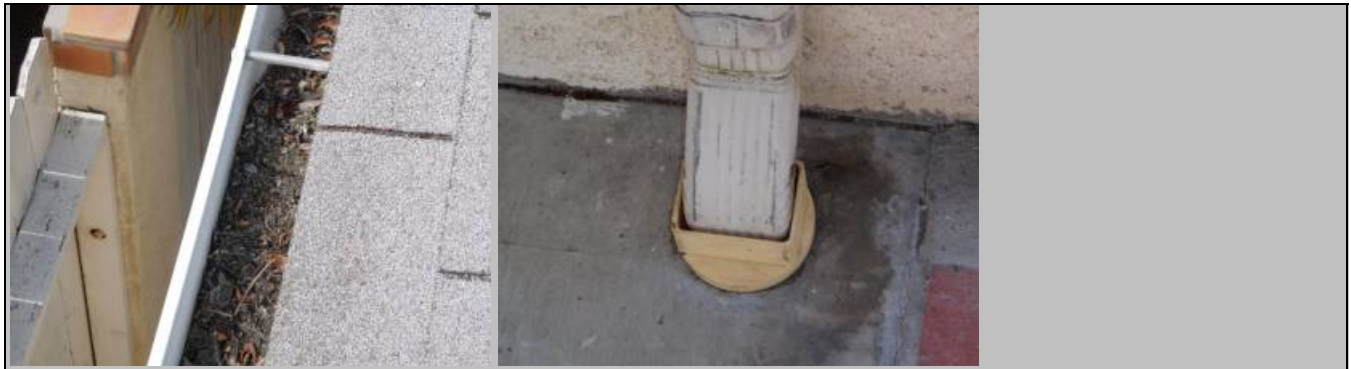
6.9 Roof or deck drains / Rain gutters

MAINTENANCE: Debris noted in the gutters. We recommend cleaning the gutters now and prior to each rainy season and periodically as needed. We suggest installing debris netting to prevent blockage.

DEFERRED: Downspout(s) discharge into an underground drainage system. Due to concealment these systems are beyond the scope of a professional home inspection and are not evaluated. We suggest asking the current owner to disclose any problems, past or present with site drainage. A video scope inspection by others is available and recommended. Annual inspection and maintenance of underground drainage systems should be done prior to each rainy season for optimal performance.

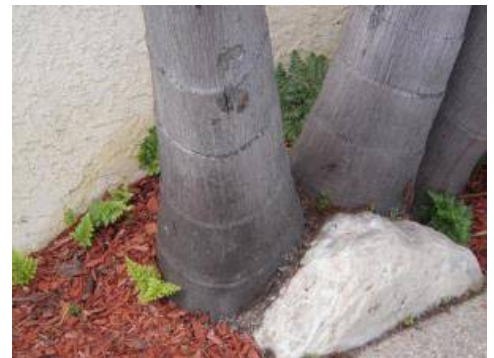
7.4 Perimeter foundation

DEFERRED: Tree(s) planted close to the building may cause damage to the foundation. We recommend removal or further evaluation by a qualified licensed landscaper or arborist for additional information.

DEFECTIVE: Leaning foundation wall on east side of house. We recommend further evaluation by a qualified registered geotechnical engineer.

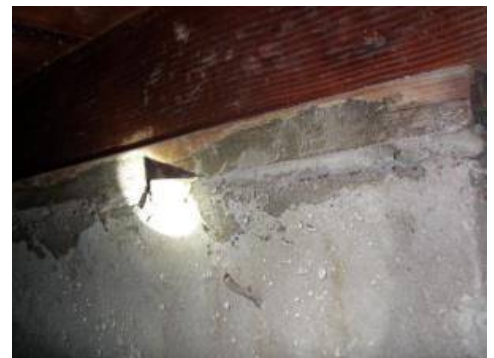
7.8 Interior foundation

DEFERRED: Mortar and shims. We recommend further evaluation by a qualified registered geotechnical engineer.

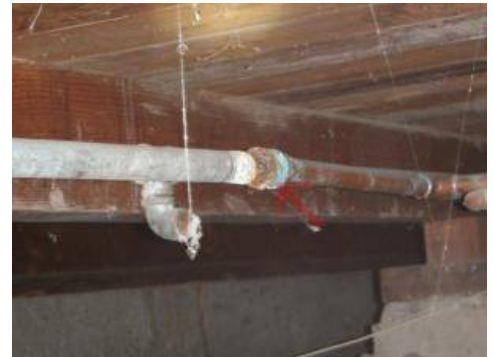
DEFECTIVE: Missing dielectric coupling at one or more locations. Where copper and galvanized pipes are connected together a dielectric coupling, or section of brass pipe must be used to control galvanic corrosion and premature leakage.

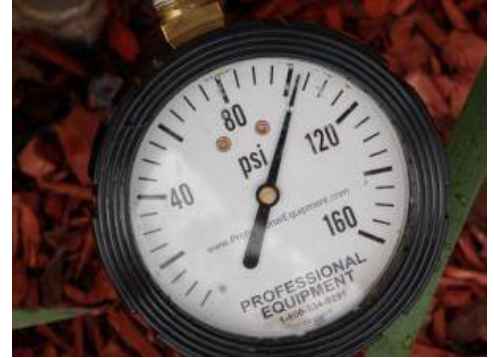
101 pounds per square inch at the time of our inspection. Water pressure may fluctuate depending on time of day and other variables.

DEFECTIVE: Excessive water pressure. We recommend installing a pressure regulator to lower the water pressure below 80 p.s.i. to reduce stress on the plumbing components. Ideal water pressure is 50-60 p.s.i.

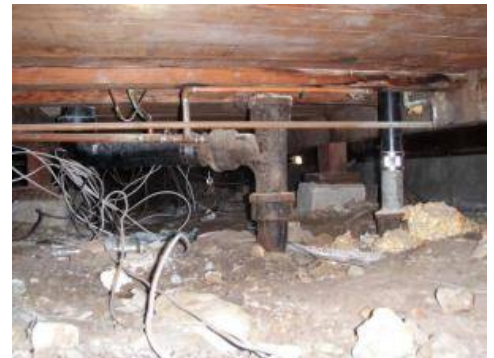
9.10 Primary type material

Cast iron and ABS (plastic)

DEFERRED: Due to the age of this building we recommend having a video scan to determine the interior condition of the sewer line (service available by others). Repairs can be expensive and this is the best non-intrusive way to determine the sewer line condition.

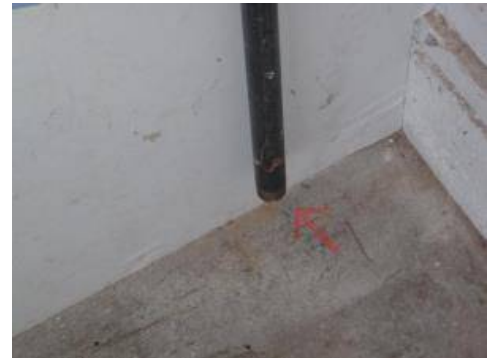
DEFECTIVE: Improper termination of discharge line. The end of the discharge line should terminate at the exterior of the building or other approved location.

DEFECTIVE: Improper discharge line termination. This line should terminate 6~24-inches from the ground to prevent injury in the event of steam discharge.

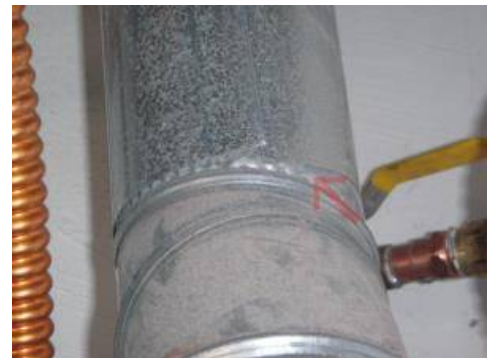
10.7 Vent system

DEFECTIVE: Sections of the connector pipe are not screwed together or the draft hood is not properly secured. Each joint of the vent connector pipe should be secured with three screws and the draft hood securely attached to the tank to prevent accidental displacement.

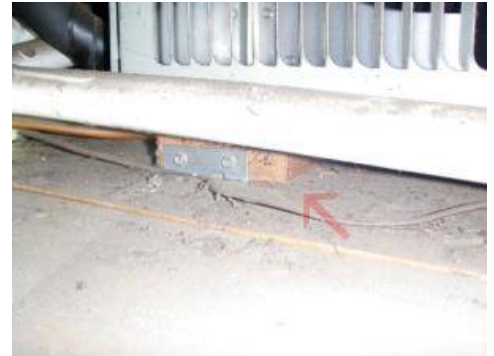
11.5 Clearance

DEFECTIVE: Insufficient clearance to combustibles.

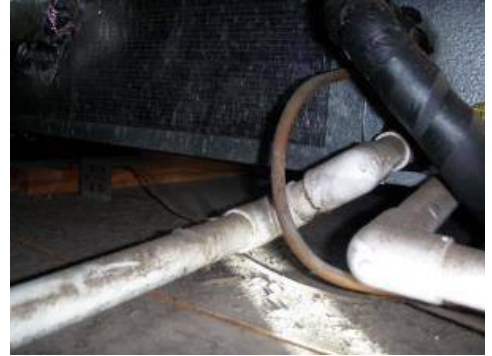
MONITOR: Secondary drain located at gable vent, If water is observed discharging from this pipe you should call a refrigeration contractor to further evaluate, it may indicate a clogged primary line or other condition needing immediate attention.

MAINTENANCE: We recommend installing a catch pan with a separate drain line to the exterior under the cooling coils on units located in attics to catch the overflow condensate in the event the primary pan overflows or leaks.

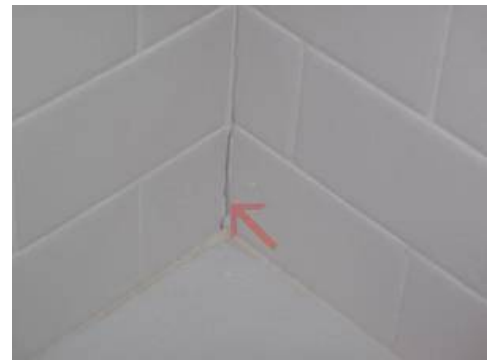
15.9 Bathtub

DEFERRED: Cracks in corners of tile, may indicate settlement.

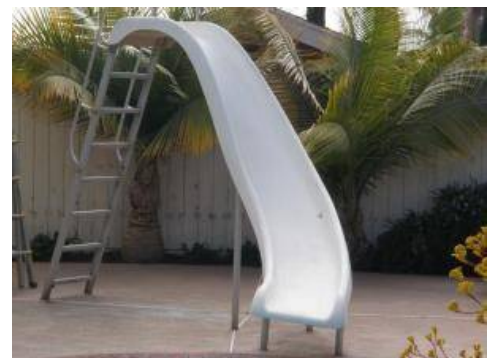
SAFETY: Pool slide present, we recommend removing for safety reasons.

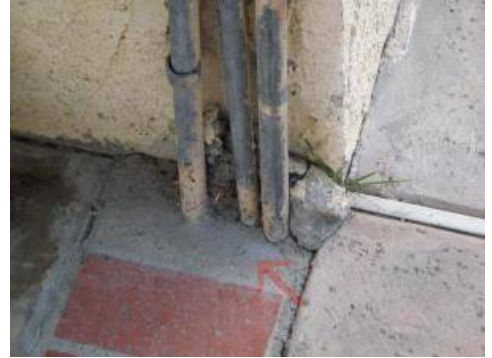
16.12 Exterior wiring observations

DEFECTIVE: Electrical Metallic Tubing (EMT) is buried. This type of conduit is not approved for burial unless properly coated. No evidence of coating visible.
